**Client:** Cliff Scaffoldings (P) Ltd  
**Job Number:** 10337  
**Project:** Assessment of Right Angle Couplers  
**Test Type:** Distortion  
**Test Method:** AS/NZS 1576.2 - 2009 Appendix B

**Test Date:** 4/7/2012  
**Manufacturer's Reference and Batch Number:** 140312INT  
**Number of Couplers Tested:** 6  
**Number of Couplers that Passed Test:** 6

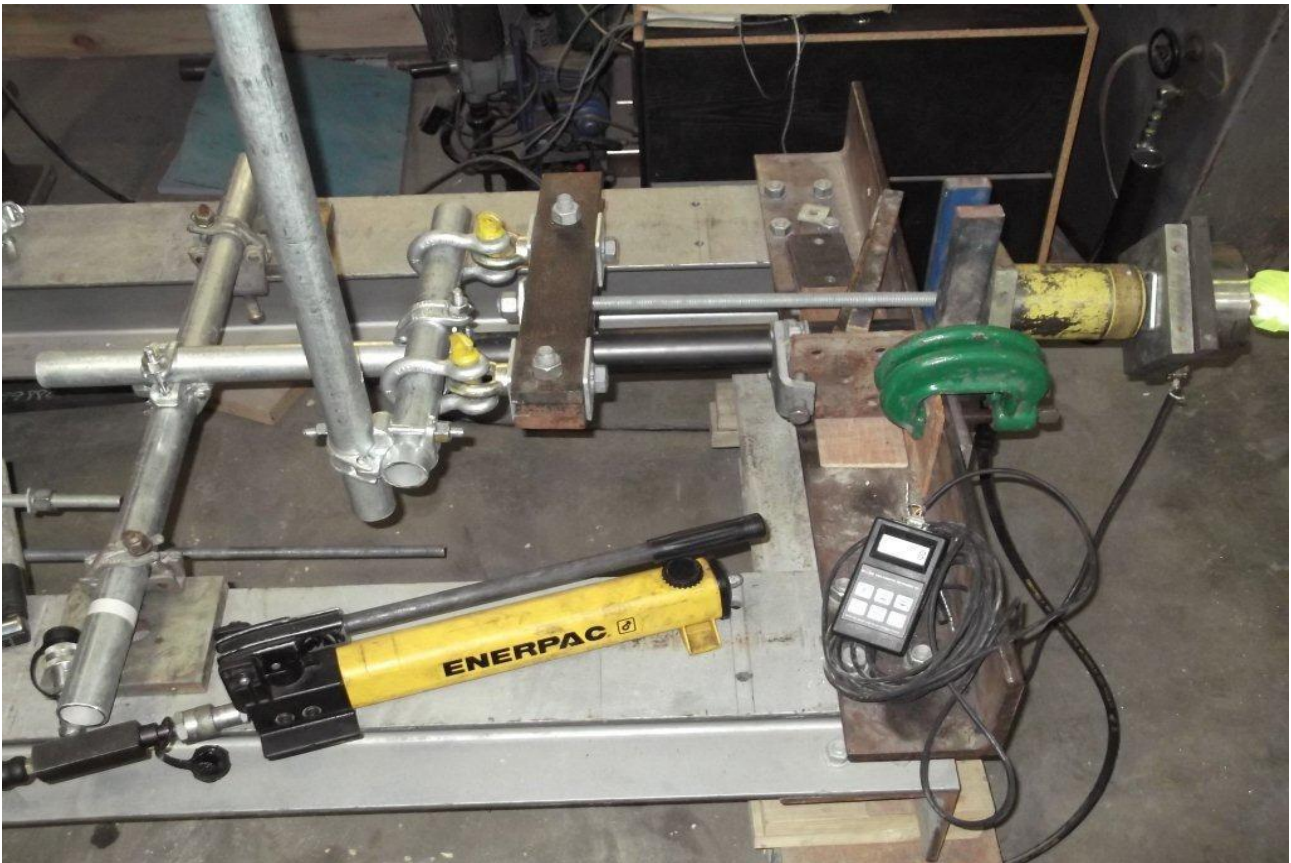
**PHOTOGRAPH 1 - General layout of test apparatus**

Note the black sleeve in the photo which acts to prevent slip of the test item, as well as the load cell on the far right hand side of the photograph

Methodology: the testing was undertaken in accordance with the Method. Load was applied via an hydraulic ram acting against a n electronic digital load cell. A 600mm long tubular member was attached to the loading member as per the Method, and rotation of the coupler under test was assessed by use of a steel millimetre rule to measure displacement of the end of the tubular member. Photograph 1 (below) shows the general layout of the test apparatus.
